ASBESTOS SURVEY REPORTS

DEPARTMENT OF TRANSPORTATION DISTRICT 11, SAN DIEGO

JUNE 1999

Department Of General Services Real Estate Services Division 1300 I Street, Suite 700 Sacramento, CA 95814

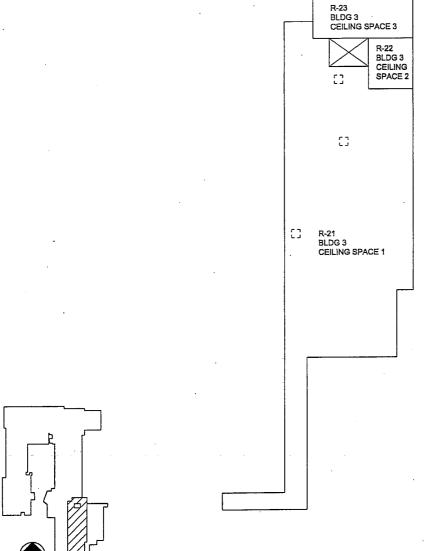
[] = CEILING SPACE ACCESS

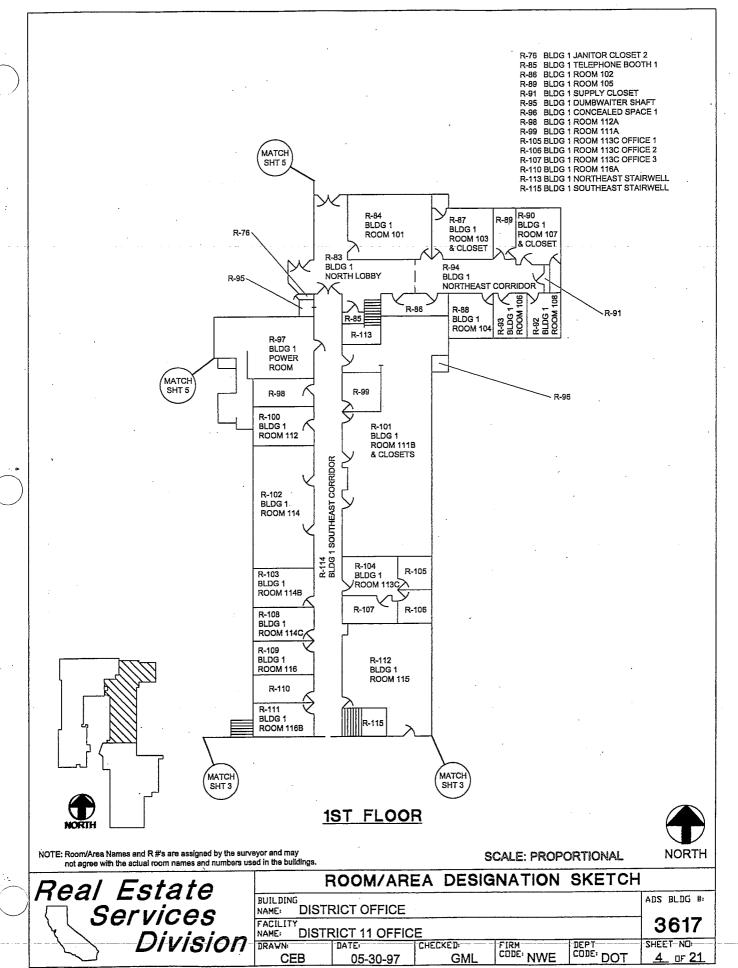
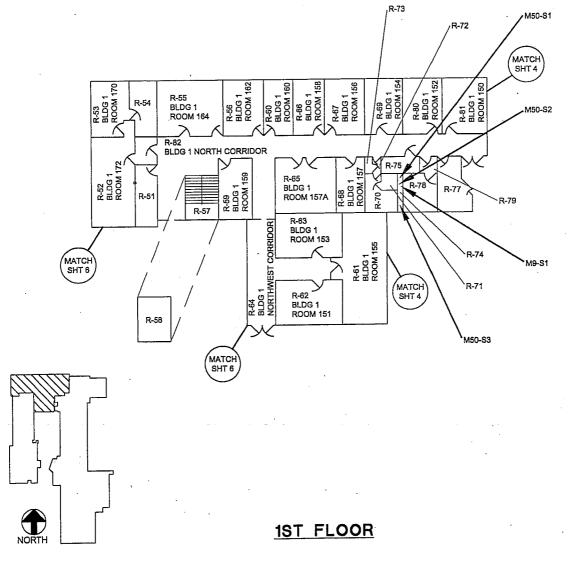
ROOM/ARI	EA DESIG	NATION	SKETCH	
BUILDING NAME: DIST	RICT OFFICE				ADS BLDG #:
FACILITY NAME: -DISTI	3617				
DRAWN:	DATE:	CHECKED:	FIRM	DEPT	SHEET-NO:
CEB	05-30-97	GML	CODE: NME	CODE: DOT	2 of 21

R-51 BLDG 1 ROOM 176
R-54 BLDG 1 ROOM 188
R-57 BLDG 1 NORTHWEST STAIRWELL
R-58 BLDG 1 NORTHWEST STAIRWELL SWITCH ROOM
R-70 BLDG 1 MENS RESTROOM 1
R-71 BLDG 1 MENS RESTROOM 1 STORAGE
R-72 BLDG 1 MENS RESTROOM 1 VESTIBULE
R-78 BLDG 1 JANITOR CLOSET 1
R-74 BLDG 1 PIPECHASE 1
R-75 BLDG 1 JANITOR CLOSET 2
R-77 BLDG 1 WOMENS LOUNGE 1
R-78 BLDG 1 WOMENS RESTROOM 1
R-79 BLDG 1 WOMENS RESTROOM 1

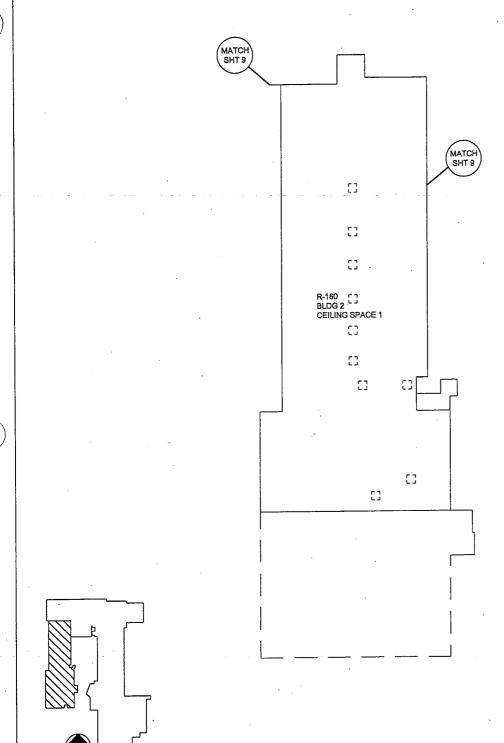
1ST FLOOR CEILING SPACES

[] = CEILING SPACE ACCESS

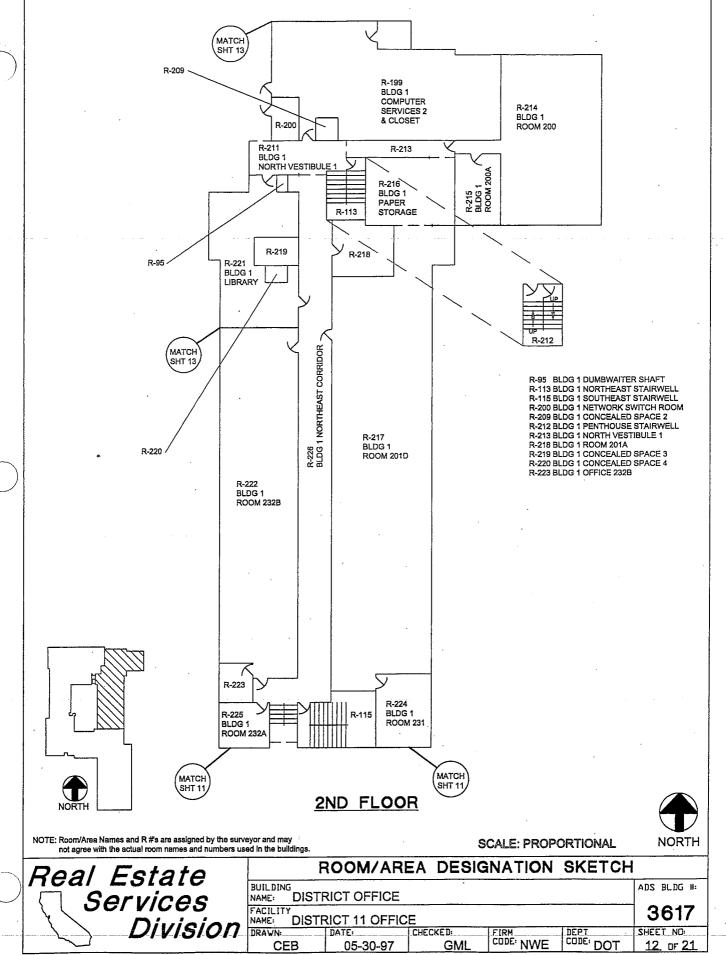
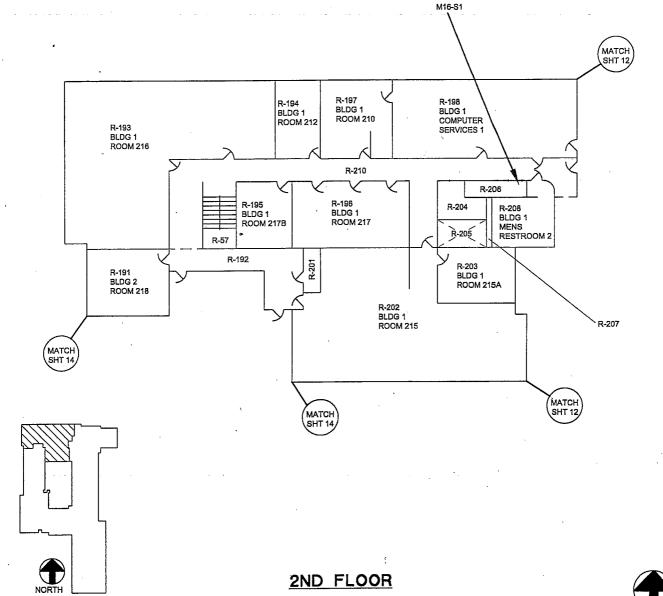
ROOM/AREA DESIGNATION SKETCH							
BUILDING	RICT OFFICE	****			ADS BLDG #:		
	KICT OFFICE				2617		
FACILITY NAME: DIST	3617						
DRAWN:	DATE:	CHECKED:	FIRM	DEPT	SHEET NO:		
CEB	05-30-97	GML	CODE: NWE	CODE: DOT	10 of 21

R-57 BLDG 1 NORTHWEST STAIRWELL
R-192 BLDG 2 NORTH VESTIBULE
R-201 BLDG 1 COMPUTER SERVICES STORAGE
R-204 BLDG 1 WOMENS RESTROOM 2
R-205 BLDG 1 VERTICAL DUCT CHASE
R-206 BLDG 1 JANITOR CLOSET 3
R-207 BLDG 1 PIPECHASE 2
R-210 BLDG 1 NORTH CORRIDOR 2
